**TOWN OF HIGHLAND BEACH
BEACH RESTORATION FEASIBILITY STUDY
2023**

**Submitted to:
The Town of Highland Beach**

**Aptim Environmental & Infrastructure, LLC
6401 Congress Avenue, Suite 140
Boca Raton, FL 33487**

January 2024

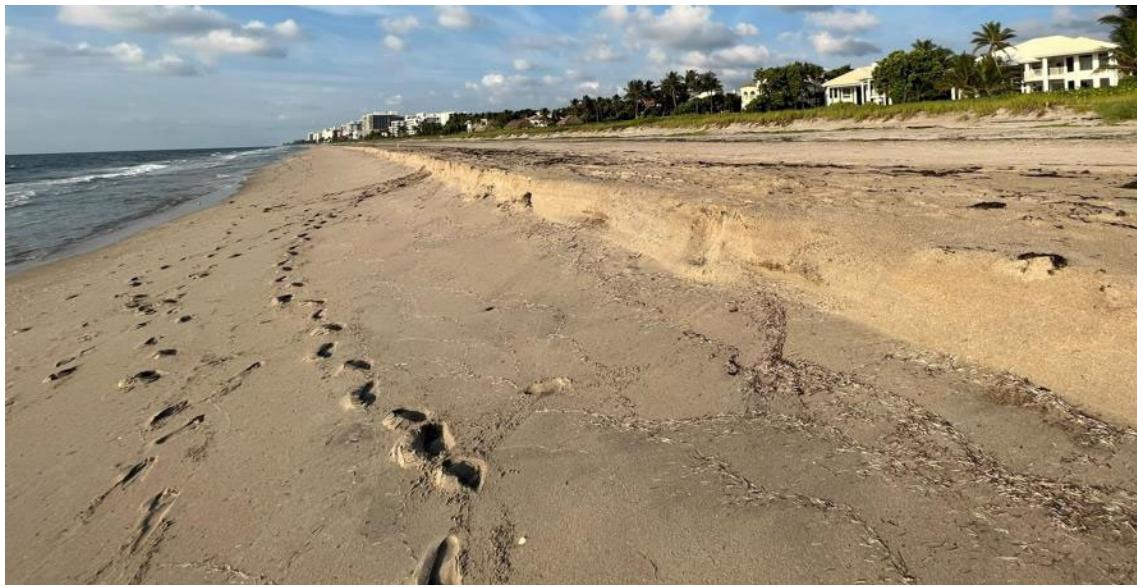
Photo 1. View looking south at the Highland Beach-Delray Beach municipal boundary. The berm has an approximate 20-inch scarp which diminishes to the south.

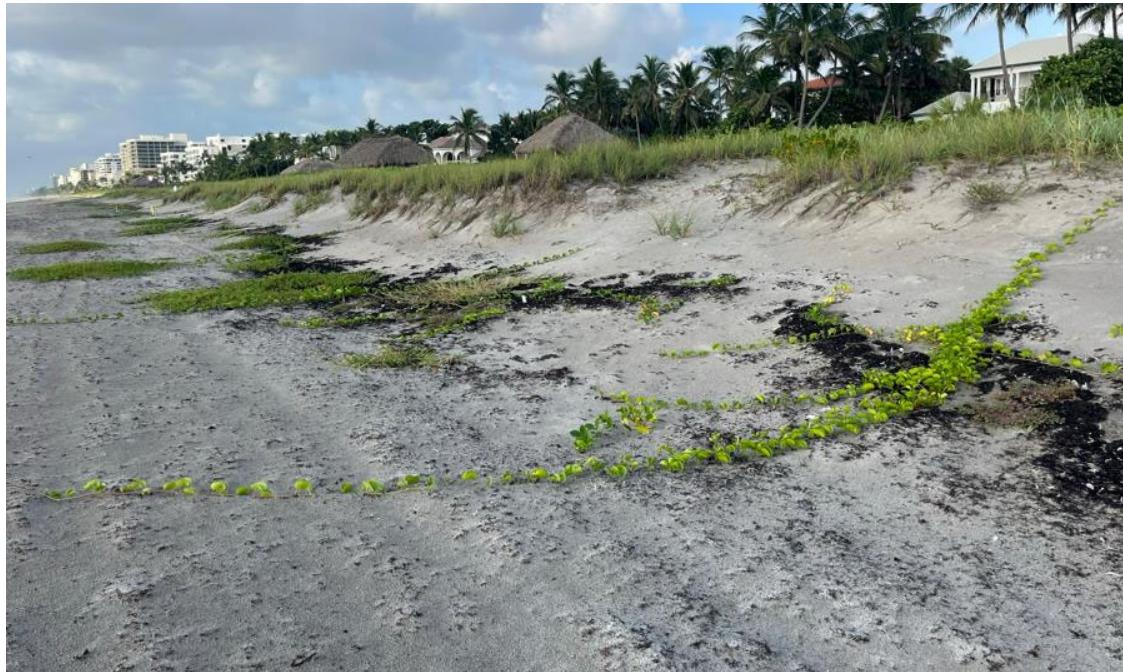
Photo 2. Eroded dune face with historical wrack lines at the toe of the dune.

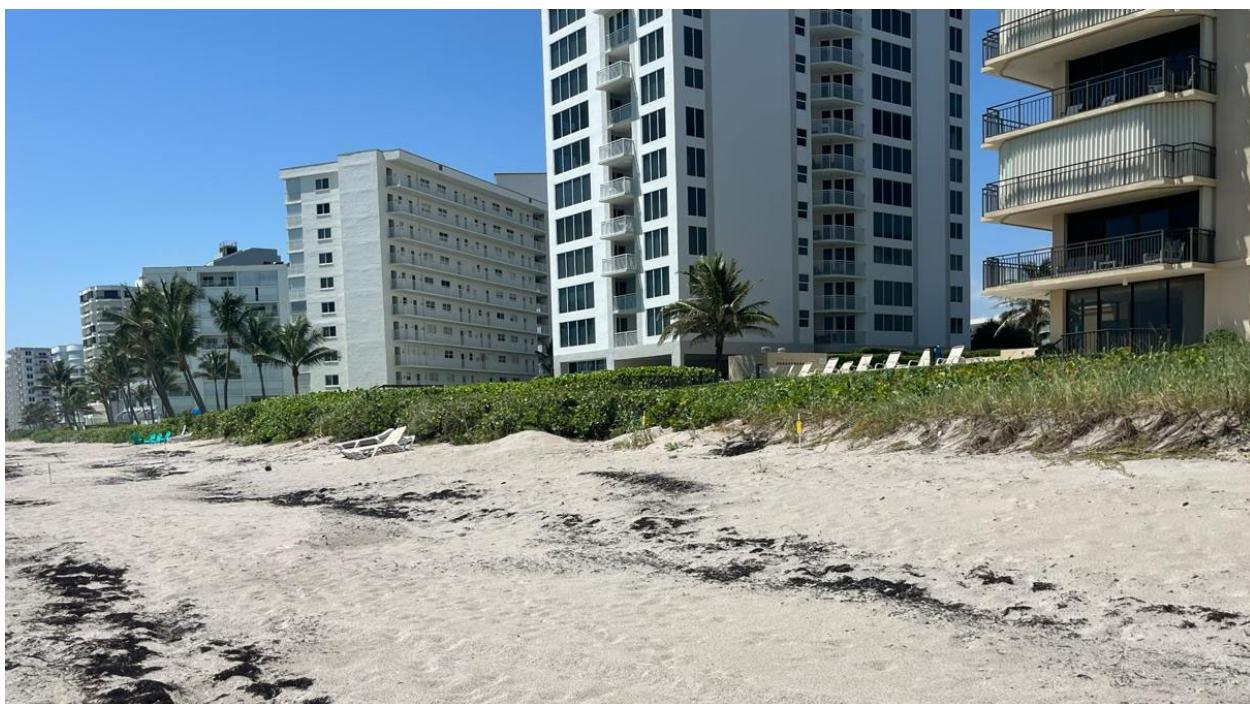
Photo 3. (From right to left) The scarped dune toe in front of Ocean Pines Condo. The scarped dune toe is hidden behind the seagrapes in front of Ocean Dunes Condo.

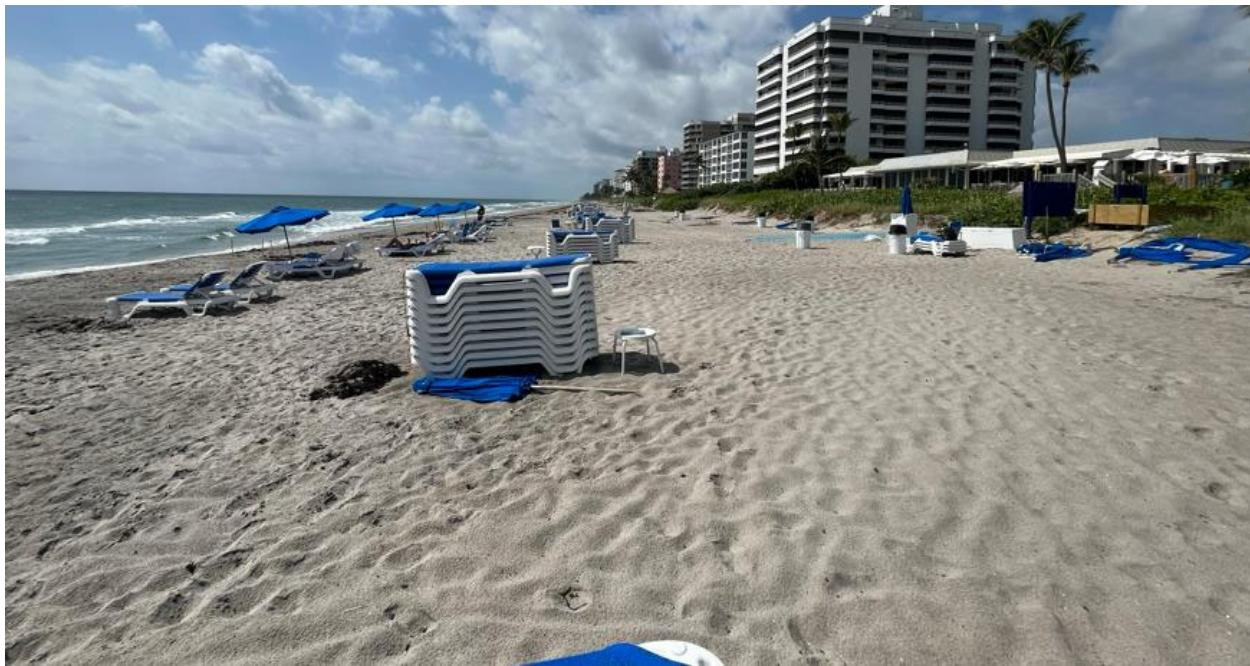
Photo 6. View looking south along the beach in front of the Delray Sands.
Note the berm and mild foreshore slope.

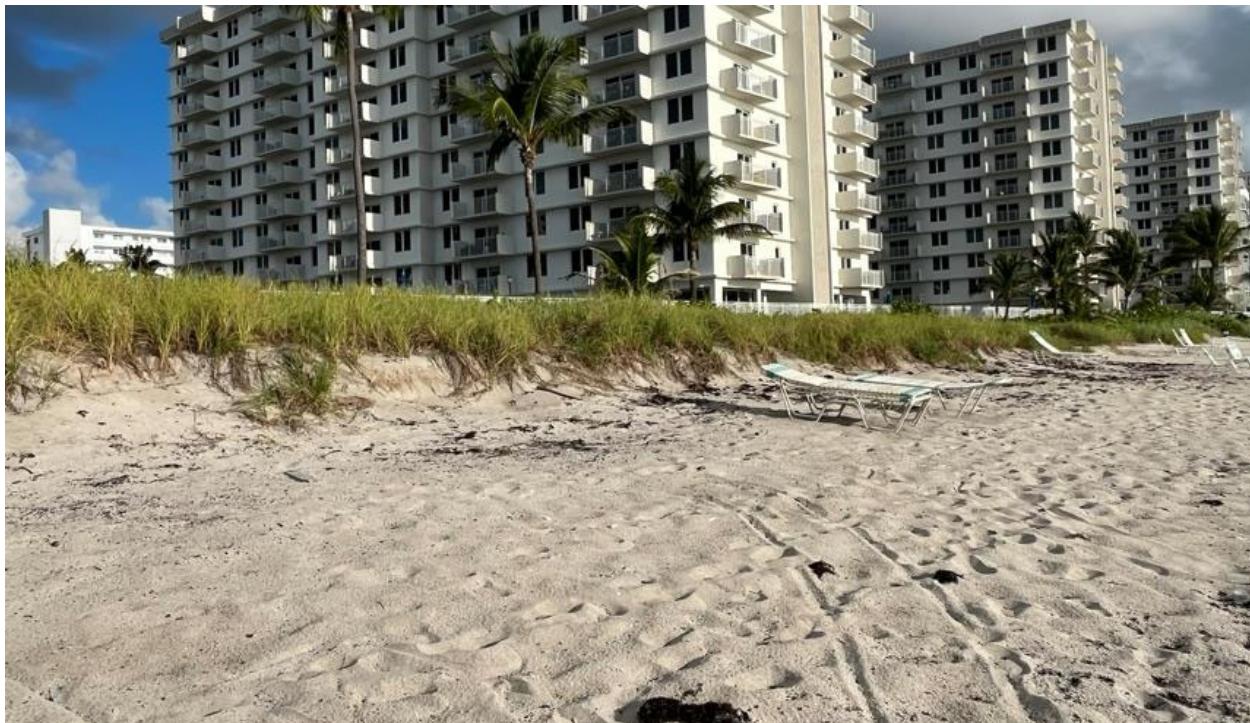
Photo 7. View to the north along the beach in front of the Ambassadors South Condo.
Note the scarped dune face and dune toe.

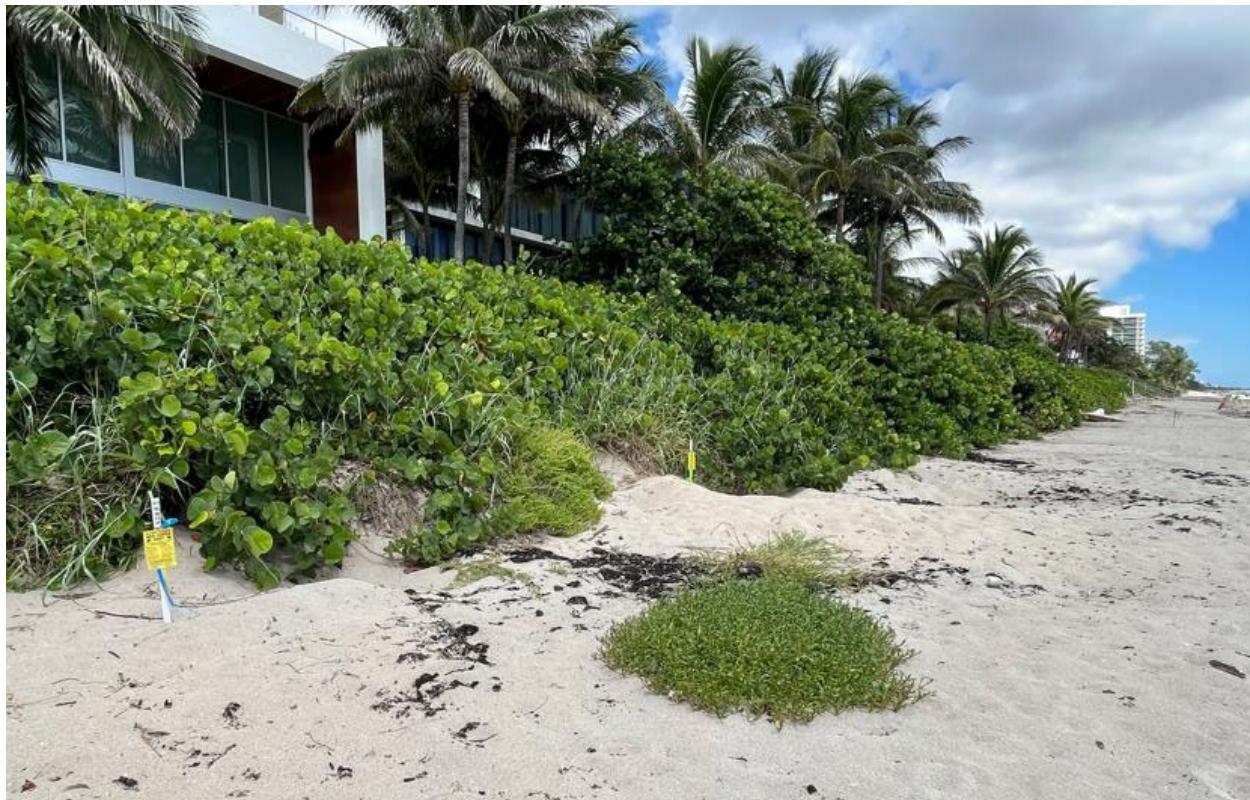
Along this section of the Town's shoreline, sections of the dunes are well vegetated, however, some areas have been undermined at the base of the vegetation and some dune scarping were visible along the shoreline (Photo 8). The elevation of the dune ranges from +15 feet, NAVD to +23 feet, NAVD. Profile R-199 had a lower dune elevation at +12 feet, NAVD, which provides limited protection.

Photo 8. Dune face scarping is resulting in undermining of the dune vegetation¹ in front of 3715 South Ocean Boulevard.

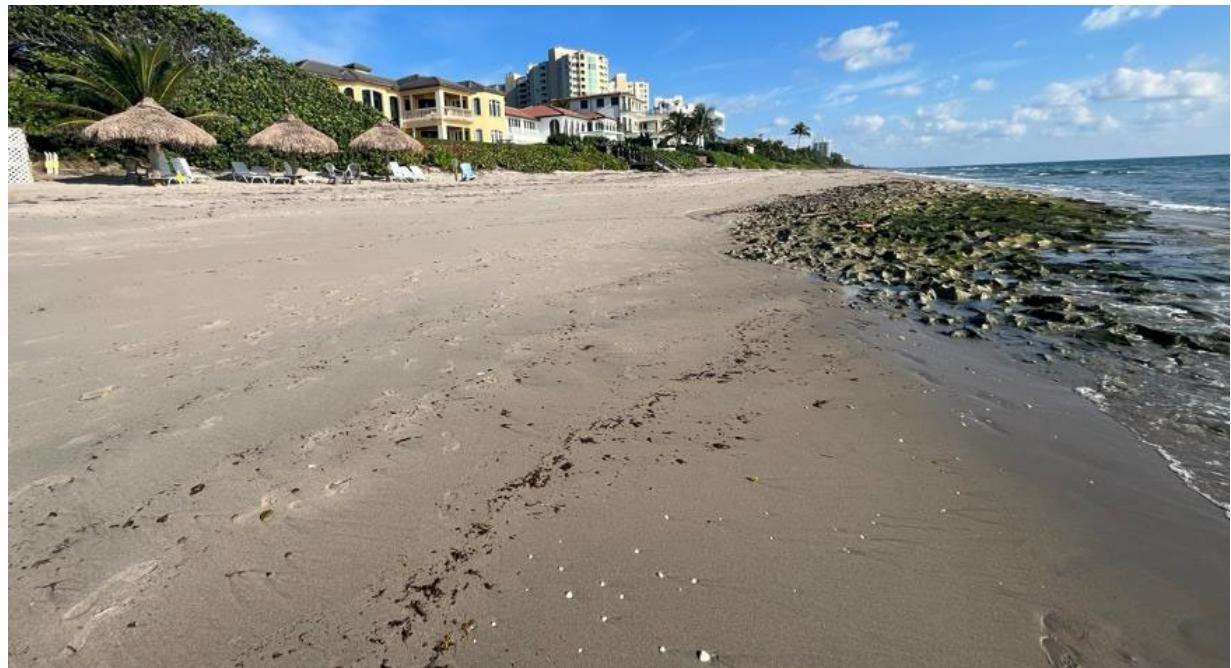
Persistent hardbottom first appears in this reach (Photos 9 and 10). In Photo 9, the outcrop in this area acts as a breakwater, holding the sand up on the adjacent property. In Photo 10, the rock outcrop functions more like a low-profile groin with a wider beach on the north side of the outcrop fronting 4201 and a receded shoreline on the south side of the outcrop, fronting Ocean Place Villas.

Photo 9. Looking north, the exposed hardbottom observed in front of the Regency Highland Club and 3907 South Ocean Boulevard.

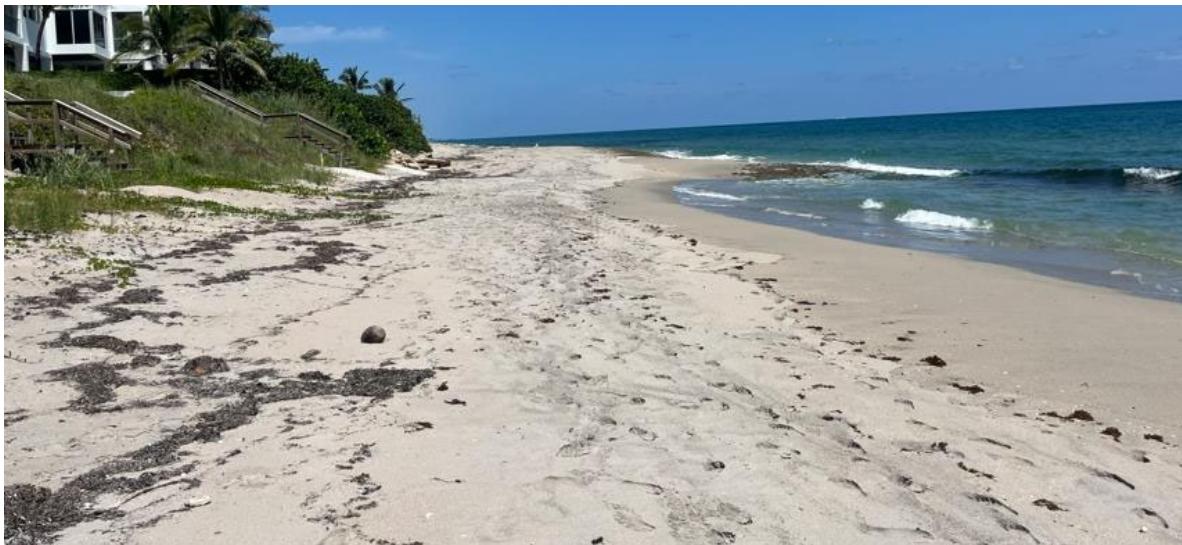
Photo 10. Looking north, the beach narrows to the south of the outcrop, fronting Ocean Place Villas.

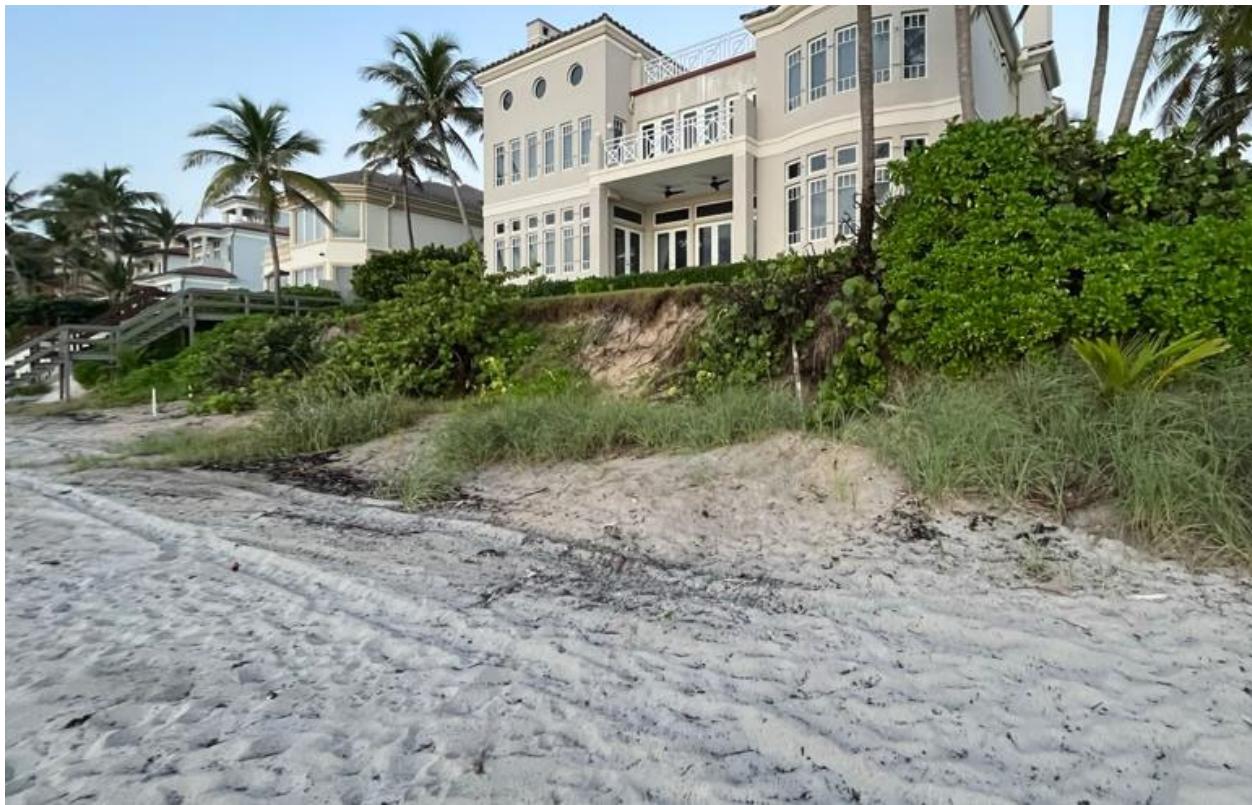
Photo 11. The most significant erosion observed in the Ocean Place Estates.

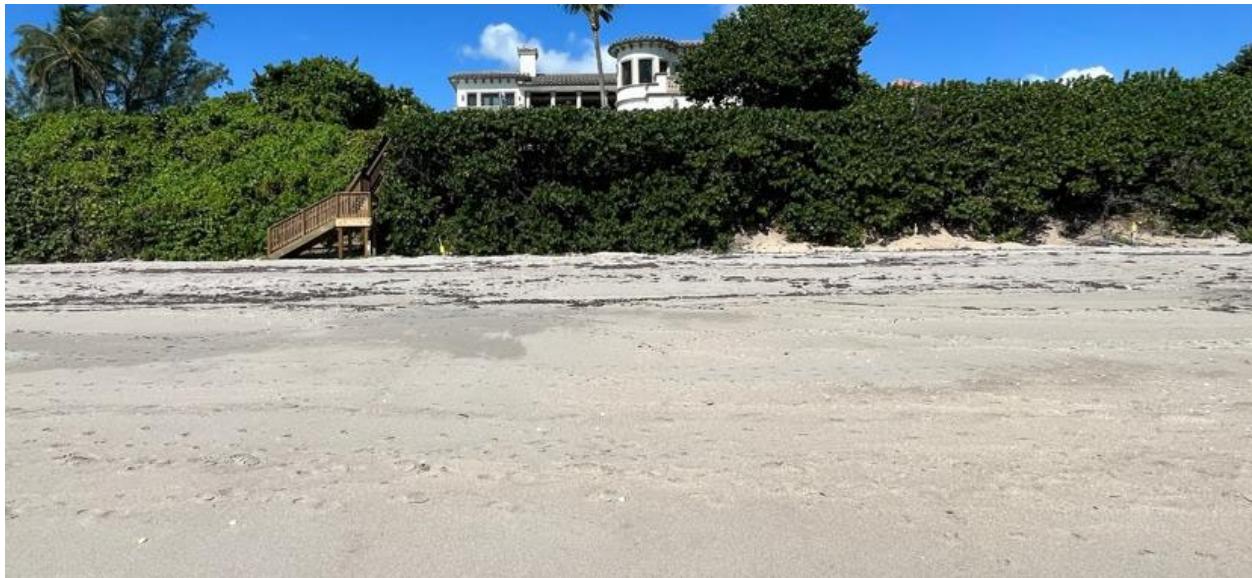
The next stretch of properties located to the north of Yamato Rock, consist of single-family homes, townhomes, and the Parker Highland Condominium. These properties have higher, vegetated dunes, except for the 4515-4519 townhomes, where the dune fronting this property is approximately 3-4 feet lower than the adjacent properties. Although the remaining properties have densely vegetated, high dunes, undermining is occurring at the base of these plants, with ~4-5 feet of scarp in some areas (Photo 12).

Photo 12. Some properties to the north of Yamato Rock have densely vegetated, high dunes; however, undermining is occurring at the base of these plants, with ~4-5 feet of scarp in some areas north of the stairs.

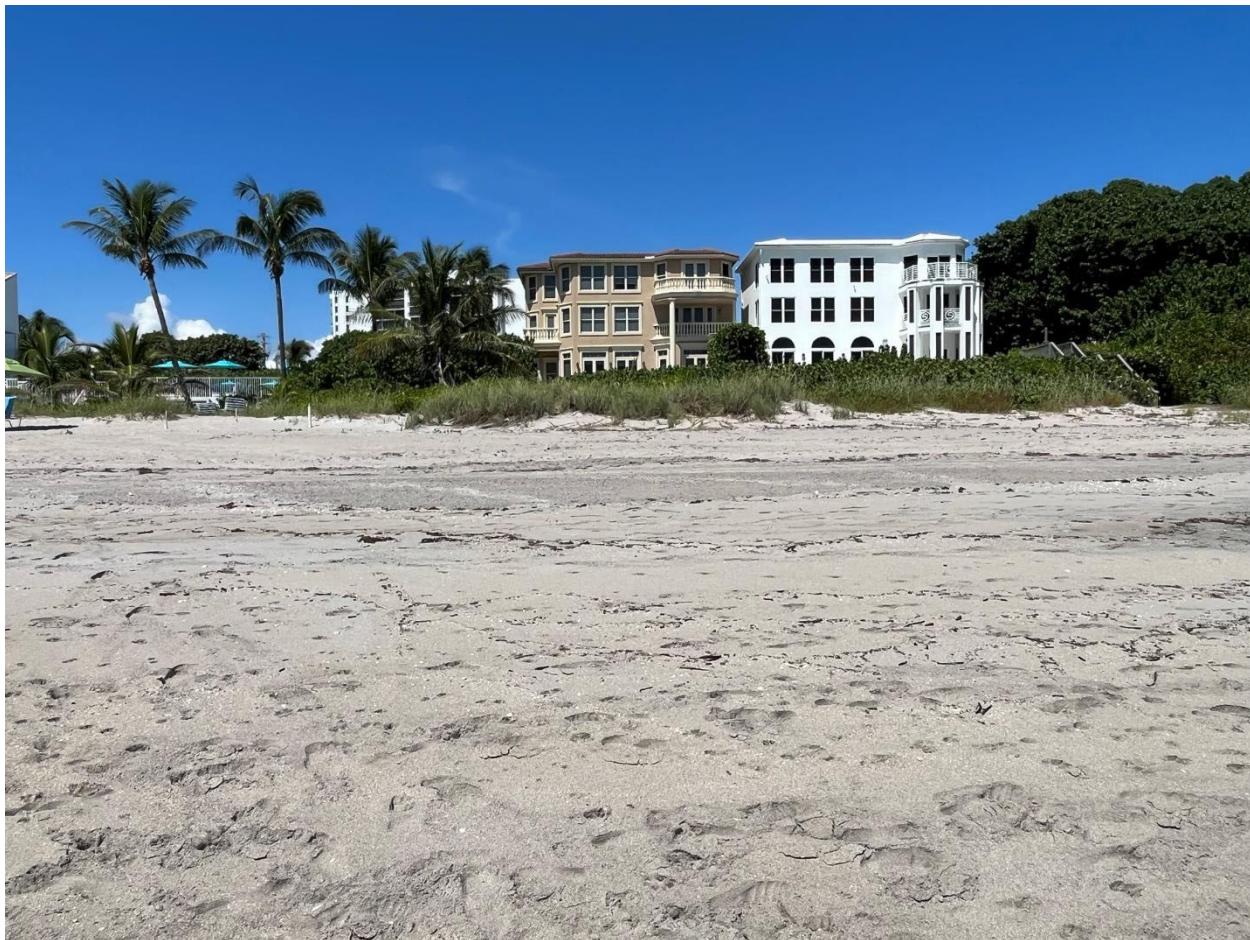
The beach access for the Admiral Walk Towers is at the limits of Highland Beach, with a 100-foot-wide vegetated dune with no structures present on this beach parcel. While the dune is wide in this area, the dune crest is at approximately +10 feet, NAVD (FDEP profile R-204, Appendix A), which is the lowest dune in Highland Beach. The dune crest is at the elevation of 100-year return period storm surge (Photo 14).

Photo 14. West view of the two single family homes and a portion of the Boca Highland Beach Club. Note the elevation of the dune relative to the adjacent Milani Park parcel.

The two single family homes and the Boca Highland Beach Club at the south end of Town have the lowest dune elevations in the Town. For those properties, this alternative is not recommended.

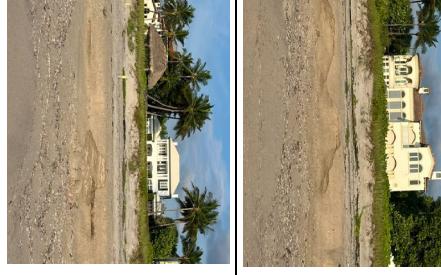
<ul style="list-style-type: none"> - Wide beach - Delray gray sands - ~19" berm scarp - Historical wrack line at the toe of the dune - There is a depressed area mid-berm with 2 additional wrack line - Nearshore bar with a 12-18" trough at the low-tide water line. - High tide/wave run-up 	<ul style="list-style-type: none"> - Dune crest elevation is ~3.5-4' above berm elevation - ~2.5-3' of dune scarp, with a 1H:3V seaward slope - Back dune areas have a 2H:1V slope towards the dune crest - Top of dune comprised of panic grass, sea oats; railroad vines at the toe of the scarp line - Seaward dune vegetation thinning/dying at scarp line 	No	No	Restore dune toe with 2cy/ft of sand along east dune toe. Revegetate dune toe with pioneer zone dune vegetation.

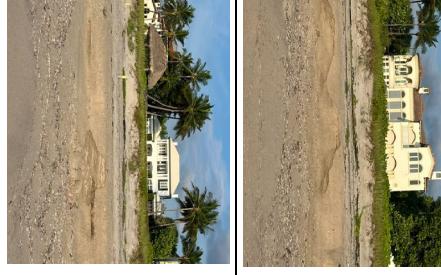
<ul style="list-style-type: none"> - Wide beach - Delray gray sands - ~18" berm scarp - Historical wrack line at the toe of the dune - There is a depressed area mid-berm with 2 additional wrack line 	<ul style="list-style-type: none"> - Dune crest elevation is ~4-4.5' above berm elevation - ~2.5-3' of dune scarp, with a 1H:3V seaward slope - Back dune areas have a 2H:1V slope towards the dune crest - Top of dune comprised of panic grass, sea oats; railroad vines at the toe of the scarp line - Seaward dune vegetation thinning/dying at scarp line 	No	No	Restore dune toe with 2cy/ft of sand along east dune toe. Revegetate dune toe with pioneer zone dune vegetation.
2365 S Ocean Blvd

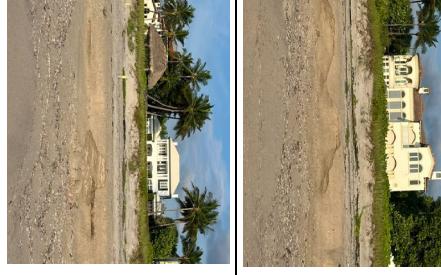
<ul style="list-style-type: none"> - Wide beach - Delray gray sands - ~16" berm scarp - Historical wrack line at the toe of the dune - There is a depressed area mid-berm with 2 additional wrack line 	<ul style="list-style-type: none"> - Dune crest elevation is ~4.5-5' above berm elevation - ~2.5-3' of dune scarp, with a 1H:2V seaward slope - Other areas of dune have a 2H:1V slope - Top of dune comprised of panic grass, sea oats; railroad vines at the toe of the scarp line - Seaward dune vegetation thinning/dying at scarp line 	No	No	Restore dune toe with 2cy/ft of sand along east dune toe. Revegetate dune toe with pioneer zone dune vegetation.

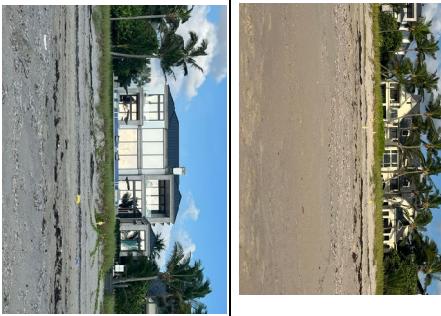
<ul style="list-style-type: none"> Wide beach Delray gray sands berm scarp leveled off Historical wrack line at the toe of the dune Mid-berm has 1 additional wrack line 	<ul style="list-style-type: none"> Dune crest elevation is ~2.5-3' above berm elevation ~5-1' dune scarp on N property line & ~1.5-2' of dune scarp the rest of the property with a 1H:2V seaward slope Back dune areas have a 2H:1V slope Top of dune comprised of panic grass, sea oats; railroad vines extend to dune toe; dense vegetation towards the back of the dune Seaward dune vegetation thinning/dying at scarp line & thinning extends on top of dune crest landward 	No	No	Restore dune toe with 2cy/ft of sand along east dune toe. Revegetate dune to with pioneer zone dune vegetation.
2455 S Ocean Blvd

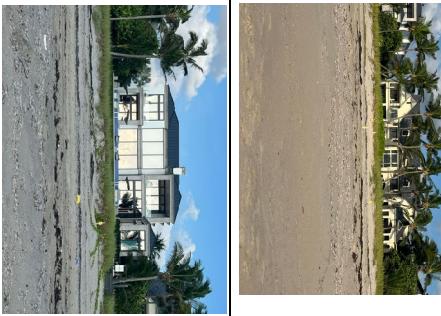
<ul style="list-style-type: none"> Wide beach Delray gray sands berm scarp leveled off Historical wrack line at the toe of the dune Mid-berm has 1 additional wrack line 	<ul style="list-style-type: none"> Dune crest elevation is ~2-2.5' above berm elevation Dune's crest appears to be positioned more landward than neighboring properties ~1.5' of dune washout/scarp, with a 2H:1V seaward slope to gradual, 3H:1V slope to the toe Vegetation on top of dune crest is thinned out ~10' landward Top of dune comprised of panic grass & sea oats; railroad vines at the toe of the scarp dune; dense vegetation (sea grape) towards the back of the dune 	No	No	Restore dune toe with 2cy/ft of sand along east dune toe. Revegetate dune to with pioneer zone dune vegetation.

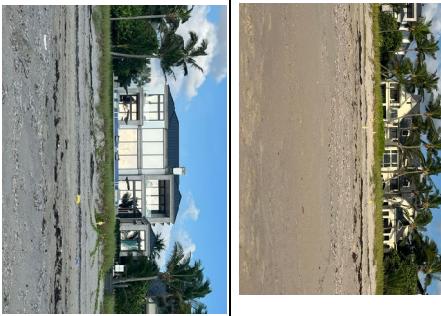
<ul style="list-style-type: none"> Wide beach Delray gray sands berm scarp leveled off Historical wrack line at the toe of the dune Mid-berm has 2 additional wrack line 	<ul style="list-style-type: none"> Dune crest elevation is ~2-2.5' above berm elevation ~1.5-2' of dune scarp, with a 1H:2V seaward slope Vegetation on top of dune crest is thinned out ~10' landward Other areas of dune have a 2H:1V slope Top of dune comprised of panic grass, sea oats; railroad vines at the toe of the scarp dune; dense vegetation (sea grape) towards the back of the dune Seaward dune vegetation thinning/dying at scarp line 	No	No	Restore dune toe with 2cy/ft of sand along east dune toe. Revegetate dune to with pioneer zone dune vegetation.

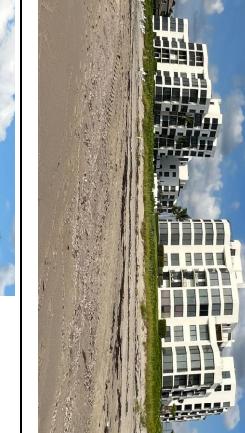
<ul style="list-style-type: none"> - Wide beach - Delta gray sands - berm scarp leveled off - Historical wrack line at the toe of the dune - Mid-berm has additional wrack line 	<ul style="list-style-type: none"> - Dune crest elevation is ~2-2.5' above berm elevation - ~1-1.5' of dune scarp, with a 2H:1V seaward slope - Other areas of dune have a 2H:1V slope - Top of dune comprised of panic grass, sea oats; railroad vines at the toe of the scarpd dune; dense vegetation (sea grape) towards the back of the dune - Seaward dune vegetation thinning/dying at scarp line 	No	No	Restore dune toe with 2cy/ft of sand along east dune toe. Revegetate dune toe with pioneer zone dune vegetation.

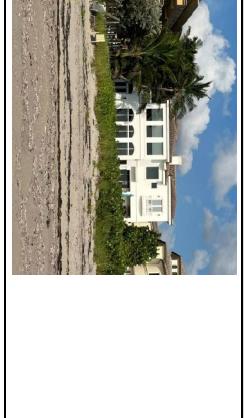
<ul style="list-style-type: none"> Wide beach Delray gray sands berm scarp leveled off Historical wrack line at the toe of the dune Mid-berm has 2 additional wrack line 	<ul style="list-style-type: none"> Dune crest elevation is ~1.5-2' above berm elevation ~1' of dune scarp, especially around the center of the property, with a 1H:1V seaward slope that gradually become a 3H:1V slope to the toe ~5' washed out vegetation extending into the toe little to no dune vegetation/grasses along south property line Top of dune comprised of panic grass, sea oats, railroad vines at the toe of the scarp dune; dense vegetation (sea grape) towards the back of the dune 	No	No	Restore dune toe with 1cy/ft of sand along east dune toe. Revegetate dune to with pioneer zone dune vegetation.
Carlton House 2701 S Ocean Blvd

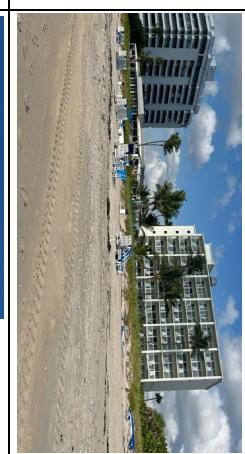
<ul style="list-style-type: none"> - Beach getting thinner - Delray gray sands - Berm scarp leveled off - Historical wrack line at the toe of the dune - Mid-berm has additional wrack line 	<ul style="list-style-type: none"> - Dune crest elevation is ~2-2.5' above berm elevation north of the steps and is ~3-4' south of the steps - North dune has ~2' scarp with a 1H:2V seaward slope and the south dune has ~3' scarp with a 1H:3V slope - Wave runup over parts of the north dune - Areas of thinned/dying vegetation on the seaward slopes - Dune comprised of panic grass, sea oats, with a dense sea grape back dune; the sea grapes along the south end of the property extend seaward to the dune crest 	No	No	Restore dune toe with 2cy/ft of sand along east dune toe. Revegetate dune to with pioneer zone dune vegetation.

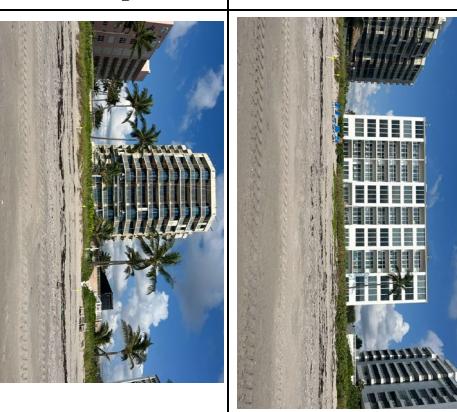
<ul style="list-style-type: none"> - Beach getting thinner - Delray gray sands - Berm scarp leveled off - Historical wrack line at the toe of the dune - Mid-berm has additional wrack line 	<ul style="list-style-type: none"> - No visible dune fronting the dense Seagrape vegetation at both end of the property; these plantings are ~1' above berm elevation - Dune crest elevation from mid-property is ~2-3' above berm elevation with ~2' scarp with a 1H:1V seaward slope - Wave runup/turtle nests have created depressed parts of seaward dune - Areas of thinned/dying vegetation on the seaward slopes - Dune comprised of sea oats, but is mainly a denser sea grape back dune 	No	Unknown	Restore dune toe with 1cy/ft of sand along east dune toe. Revegetate dune to with pioneer zone dune vegetation.
Wiltshire 2909 S Ocean Blvd

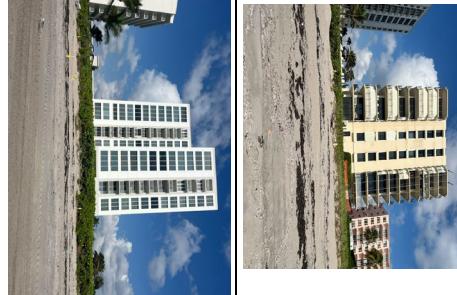
<ul style="list-style-type: none"> - Beach getting thinner - Delray gray sands, traces of Highland shelly brown sands - Berm scarp leveled off - Historical wrack line at the toe of the dune - Mid-berm has additional wrack line - Nearshore sand bar is ~40' from waterline 	<ul style="list-style-type: none"> - North dune crest elevation is ~2-2.5' above berm with ~1.5-2' scarp - South dune crest elevation is ~3-3.5' above berm with ~3' scarp - Dune has with a 1H:1V seaward slope with thinned/dying vegetation at scarp line - Back dune has 2H:1V landward slope - The dune vegetation tapers landward from north to south - Dune comprised of sea oats, fronting a denser back dune (sea grapes) start on dune crest extending landward. 	No	Yes. ~6' tall	Restore dune toe with 2cy/ft of sand along east dune toe. Revegetate dune toe with pioneer zone dune vegetation.

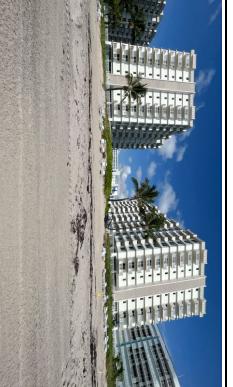
<ul style="list-style-type: none"> - Beach getting thinner - Delray gray sands, traces of Highland shelly brown sands - Berm scarp leveled off - Historical wrack line at the toe of the dune - Mid-berm has additional wrack line 	<ul style="list-style-type: none"> - Dune crest elevation is ~2.5-3' above berm elevation - Dune has ~1.5-2' scarp with a 1H:2V slope, thinned/dying vegetation at scarp line - Sea grape vegetation extends to dune toe, base of plants exposed at scarp line - The north dune crest has been washed over (wave runup) - Erosion around steps/walkway locations - Dune comprised of mainly of denser sea grape and beach naupaka, and some sea oats where some fronting dune is present; some railroad vines in wrack line 	No	No	Restore dune toe with 2cy/ft of sand along east dune toe. Revegetate dune to with pioneer zone dune vegetation.
Villa Mare 3211 S Ocean Blvd

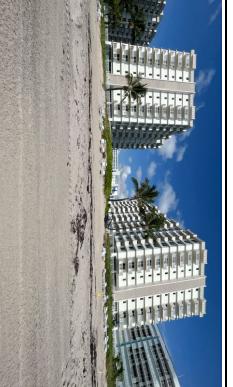
<ul style="list-style-type: none"> - Beach getting thinner - Delray gray sands, traces of Highland shelly brown sands - Berm scarp leveled off - Historical wrack line at the toe of the dune - Mid-berm has additional wrack line 	<ul style="list-style-type: none"> - Dune crest elevation is ~3' above berm elevation with ~2.5' scarp and a 1H:2V slope - Dune comprised of mainly of denser sea grape and beach naupaka, and some sea oats where some dune toe is present - Dune has thinned/dying vegetation at scarp line, exposing base of sea grape/naupaka vegetation - South dune, near steps, has been washed over (wave runup), exposed base of vegetation is positioned ~6' landward compared to rest of dune 	No	No	Restore dune toe with 2cy/ft of sand along east dune toe. Revegetate dune to with pioneer zone dune vegetation.

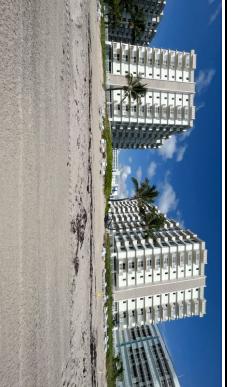
<ul style="list-style-type: none"> - Beach getting thinner - Delray gray sands, traces of Highland shelly brown sands - Berm scarp leveled off - Historical wrack line at mid-berm 	<ul style="list-style-type: none"> - Dune crest elevation is ~3' above berm elevation at edges of property with ~2.5' scarp/runup to base of vegetation - Dune crest elevation is ~3.5-4' above berm at mid dune (fronting pool area) with ~2.5' scarp and a 1H:2V slope - ~25-30' of dune vegetation fronting seawall, which thins out in front of the buildings - Dune comprised of mainly of sea oats and beach naupaka, with some palm trees - Dune has thinned/dying vegetation at scarp line, exposing base of sea grape/naupaka vegetation 	No	Yes, ~5' tall	Restore dune toe with 2cy/ft of sand along east dune toe. Revegetate dune to with pioneer zone dune vegetation.

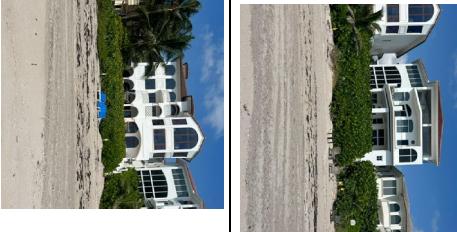
<ul style="list-style-type: none"> - Berm scarp leveled off - Historical wrack line at the toe of the dune - Mid-berm has additional wrack line - Delray gray and Highland brown sands 	<ul style="list-style-type: none"> - Dune crest elevation is ~2.5-3' above berm elevation with ~2.5' scarp/runup to dune crest - The seaward dune has a 1H:1V slope up to crest, and a 3H:1V slope back to ~5' in elevation - Dune comprised of sea oats, naupaka and sea grape vegetation, that is exposed and scraped at the base - Tall dense back dune 	No	No	Restore dune toe with 1cy/ft of sand along east dune toe. Revegetate dune toe with pioneer zone dune vegetation.
3573 S Ocean Blvd

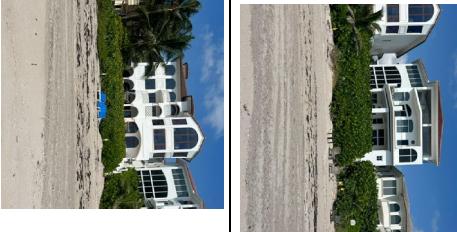
<ul style="list-style-type: none"> - Berm scarp leveled off - Historical wrack line at the toe of the dune extending to mid-berm - Delray gray and Highland brown sands - The beach is starting to get more narrow 	<ul style="list-style-type: none"> - Dune crest elevation is ~1.5-2' above berm elevation with ~1.5' scarp/runup: most of the front dune is gone - The seaward dune has a 1H:1V slope up to crest, and a 2H:1V back slope - Dune comprised of sparse sea oats of the front dune and dense sea grape vegetation, that is exposed and scraped ~1.5' at the base - Sea grapes along south property are ~10' landward and front dune has flattened, with a 4H:1V slope fronting the 	No	No	Restore dune toe with 1cy/ft of sand along east dune toe. Revegetate dune toe with pioneer zone dune vegetation. Consider removing sea grape and installing pioneer zone vegetation.
3615 S Ocean Blvd

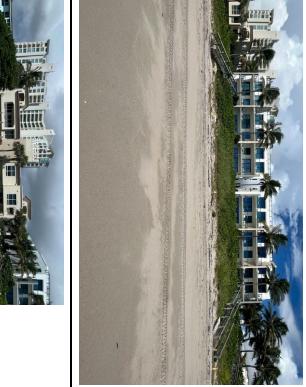
<ul style="list-style-type: none"> - Berm scarp leveled off - Historical wrack line at the toe of the dune extending to mid-berm - Dely gray and Highland brown sands - The beach is more narrow - The beach profile appears to have a steeper slope fronting this property 	<ul style="list-style-type: none"> - Dune crest elevation is ~1.5-2' above berm elevation with ~1.5' scarp/runup to crest - The seaward dune has a 1H:1.5V slope up to crest, and a 1H:1V back slope on the tail back dune - ~2' scarp behind each of the beach access steps - Front dune vegetation is sparse, comprised of sea oats/grasses and railroad vines; and dense sea grape vegetation on the back dune 	No	No	Restore dune toe with 1cy/ft of sand along east dune toe. Revegetate dune toe with pioneer zone dune vegetation. Consider removing sea grape and installing pioneer zone vegetation.

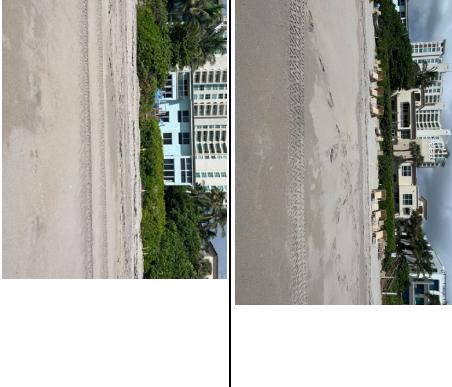
<ul style="list-style-type: none"> - Berm scarp leveled off - wrack line at crest of mid-berm slope - Dely gray and Highland brown sands - The beach is more narrow - The beach profile appears to have a steeper slope from the waterline to mid-berm - Nearshore bar is ~50' from waterline 	<ul style="list-style-type: none"> - Dune crest elevation is ~2.5' above berm elevation with ~2' scarp/runup to crest - The seaward dune has a 1H:2V slope up to crest, and a 3H:1V back slope - Dune vegetation comprised of sea oats and sunflowers with a denser sea grape and naupaka vegetation on the back dune 	No	No	Restore dune toe with 2cy/ft of sand along east dune toe. Revegetate dune toe with pioneer zone dune vegetation.
3711 S Ocean Blvd

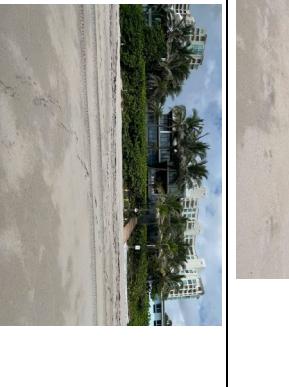
<ul style="list-style-type: none"> - Berm scarp leveled off - Historical wrack line at the toe of the dune - Mid-berm has additional wrack line - Dely gray and Highland brown sands - The beach is more narrow - The beach profile appears to have a milder slope compared to the northern adjacent property 	<ul style="list-style-type: none"> - Front dune crest elevation is ~2.5' above berm elevation with ~2' scarp/runup at base of vegetation - The seaward dune has a 1H:2.5V slope up to crest, and a 3H:1V back slope - Dune comprised of sea grape and naupaka vegetation with some snake plants 	No	No	Restore dune toe with 2cy/ft of sand along east dune toe. Revegetate dune toe with pioneer zone dune vegetation.

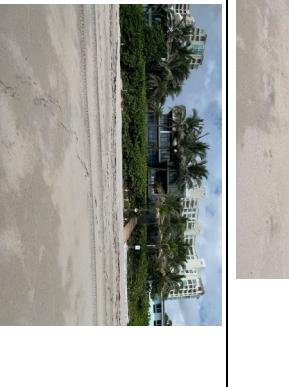
<ul style="list-style-type: none"> - Berm scarp leveled off - Historical wrack line at the toe of the dune - Mid-berm has additional wrack line - Dely gray and Highland brown sands - The beach is more narrow 	<ul style="list-style-type: none"> - Mid-property front dune crest elevation is ~1.5' above berm elevation with ~1' scarp/runup at base of vegetation - Back dune and base of sea grapes are ~3' above berm with up to ~3' scarp/runup, exposing vegetation roots - The seaward dune has a 1H:1V slope up to crest, and a 1H:3V back slope - Dune comprised of sea grape and naupaka vegetation with some palm trees - 2 layers of sandbags stacked fronting the vegetation to the north of the beach access ramp 	No	No	Restore dune toe with 2cy/ft of sand along east dune toe. Revegetate dune toe with pioneer zone dune vegetation.

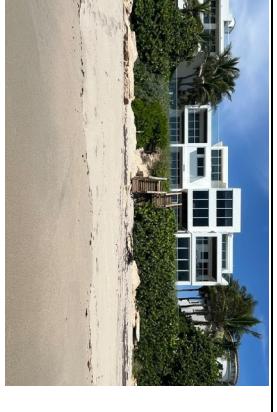
<ul style="list-style-type: none"> - Berm elevation is ~1' higher than adjacent properties - Historical wrack line at the toe of the dune extending to mid-berm - More Highland brown sands and shell hash visible - Visible, partially buried rocks dune toe (Armoring boulders?) - Rock outcrop mid-berm to the waterline 	<ul style="list-style-type: none"> - Not much of a pioneer dune present, rocks partially buried at dune toe - Dune crest elevation is ~2.5-3' above berm elevation and there is ~2-2.5' scarp base of the vegetation - Dune has a 1H:2V slope - Dune comprised of sea grape and misc. vegetation 	Yes: rocks buried at the dune toe. Most of the rock outcrop is up on the beach down, mid-berm to the waterline. Acts as a breakwater. Scour is occurring at the base of the seaward edge.	No	Restore dune toe with 2cy/ft of sand along east dune toe. Revegetate dune toe with pioneer zone dune vegetation. Consider reducing sea grape and planting pioneer dune vegetation.

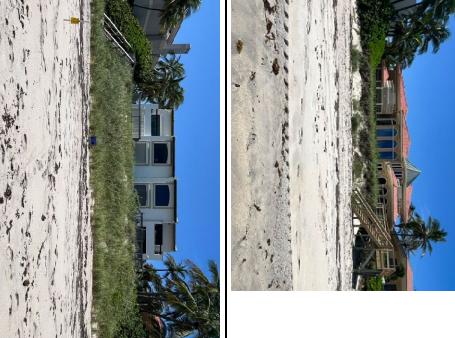
<ul style="list-style-type: none"> - Berm scarp leveled off - Narrow beach - Historical wrack line at the toe of the dune extending to mid-berm - More Highland brown sands and shell hash visible 	<ul style="list-style-type: none"> - Small dune present fronting the seawall - Dune elevation ~3' above berm elevation with a 3H:1V slope - Wave run-up visible to dune crest, with 1.5' scarp in areas - Dune comprised sea oats, naupaka, and misc. vegetation 	No	Yes; 9' tall SSP wall (with 2' conc cap)	Restore dune toe with 2cy/ft of sand along east dune toe. Revegetate dune toe with pioneer zone dune vegetation.
4221 S Ocean Blvd

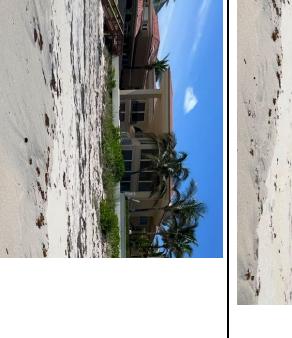
<ul style="list-style-type: none"> - Berm scarp leveled off - Narrow beach - Historical wrack line at the toe of the dune extending to mid-berm - More Highland brown sands and shell hash visible 	<ul style="list-style-type: none"> - Small dune present fronting the seawall - The north dune extends 3-8' from base of seawall, with an elevation of ~2-2.5' above the berm elevation and ~2' scarp - The south dune extends 10-15' from base of seawall, with an elevation of ~3-3.5' above the berm elevation and ~3' scarp - Wave run-up visible to dune crest with dying vegetation on seaward edge and at base of exposed roots - Dune comprised sea oats, naupaka, and misc. vegetation 	No	Yes; 7' tall SSP wall (with 1.5' conc cap)	Restore dune toe with 2cy/ft of sand along east dune toe. Revegetate dune toe with pioneer zone dune vegetation.

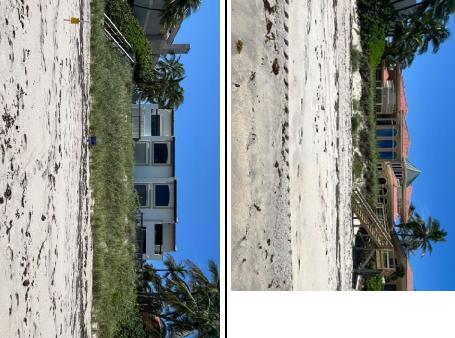
<ul style="list-style-type: none"> - Berm scarp leveled off - Narrow beach - Historical wrack line at the toe of the dune extending to mid-berm - More Highland brown sands and shell hash visible 	<ul style="list-style-type: none"> - Pioneer dune has a fallen slope, sits at an elevation ~3' above berm elevation with 2.5' scarp/runup - Severe erosion of back dune face, with ~5-6' scarp - Dune has 1H:4.5V slope - Dune comprised sea oats, naupaka, and misc. vegetation 	No	No	Restore dune toe with 2cy/ft of sand along east dune toe. Revegetate dune toe with pioneer zone dune vegetation.
Coco-de-Mar Blvd

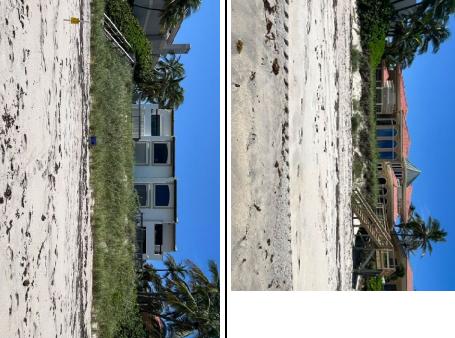
<ul style="list-style-type: none"> - Berm scarp leveled off - Narrow beach; only ~35' from waterline to dune toe - Historical wrack line at the toe of the dune extending to mid-berm - More Highland brown sands and shell hash visible - Armoring boulders located near base of steps 	<ul style="list-style-type: none"> - Dune has been newly planted with 2H:1V front slope and a 3H:1V back slope - Dune comprised sea oats - Dune toe is only ~0.5' above the berm elevation - Dune crest is ~10' above berm elevation 	No	No	No action.
