**TOWN OF HIGHLAND BEACH
BEACH RESTORATION FEASIBILITY STUDY
2023**

**Submitted to:
The Town of Highland Beach**

**Aptim Environmental & Infrastructure, LLC
6401 Congress Avenue, Suite 140
Boca Raton, FL 33487**

January 2024

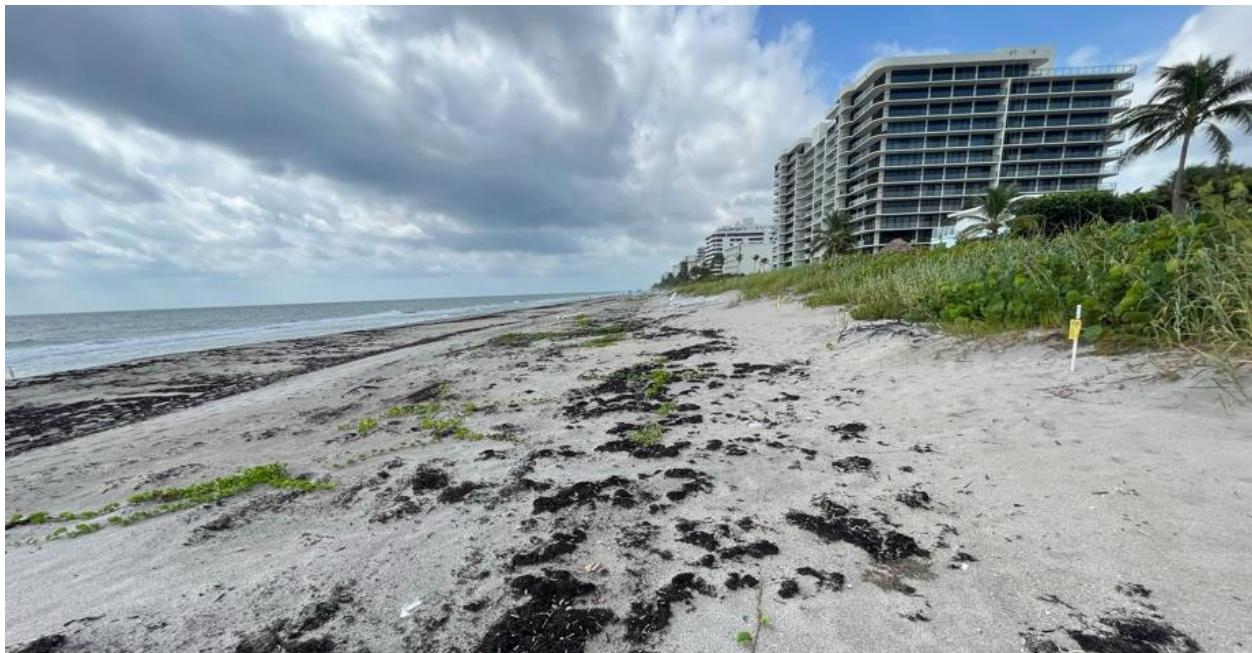
Photo 4. Southerly view of the beach berm and dune near R-192.

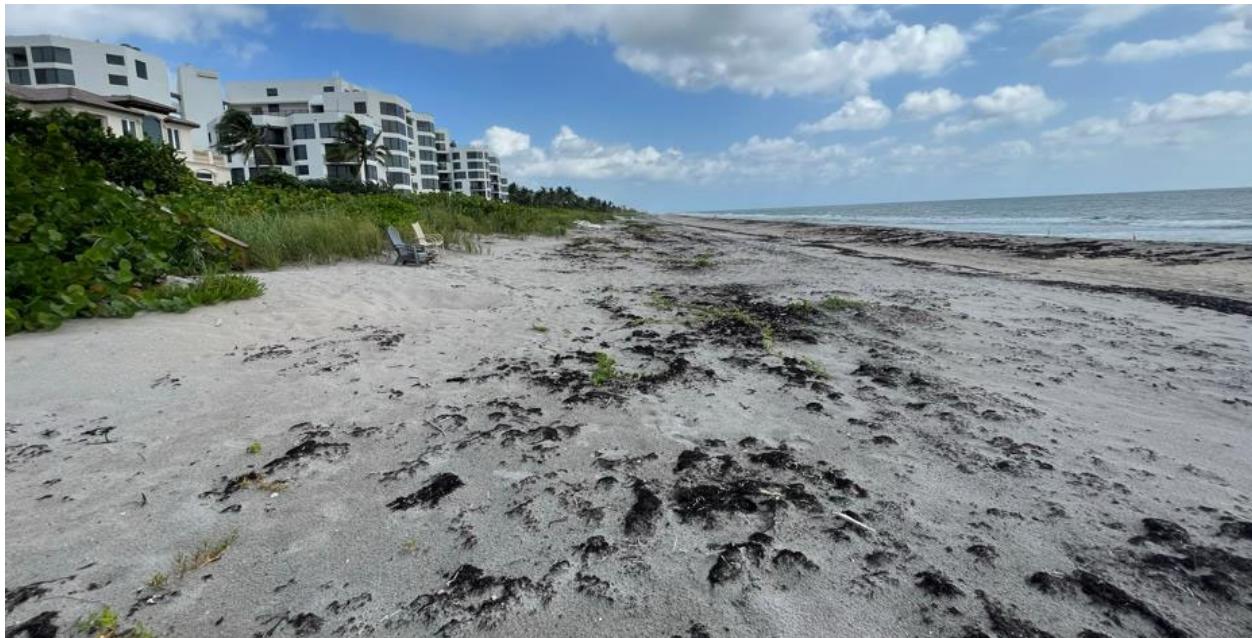
Photo 5. View of the beach berm and dune near R-192 looking north.

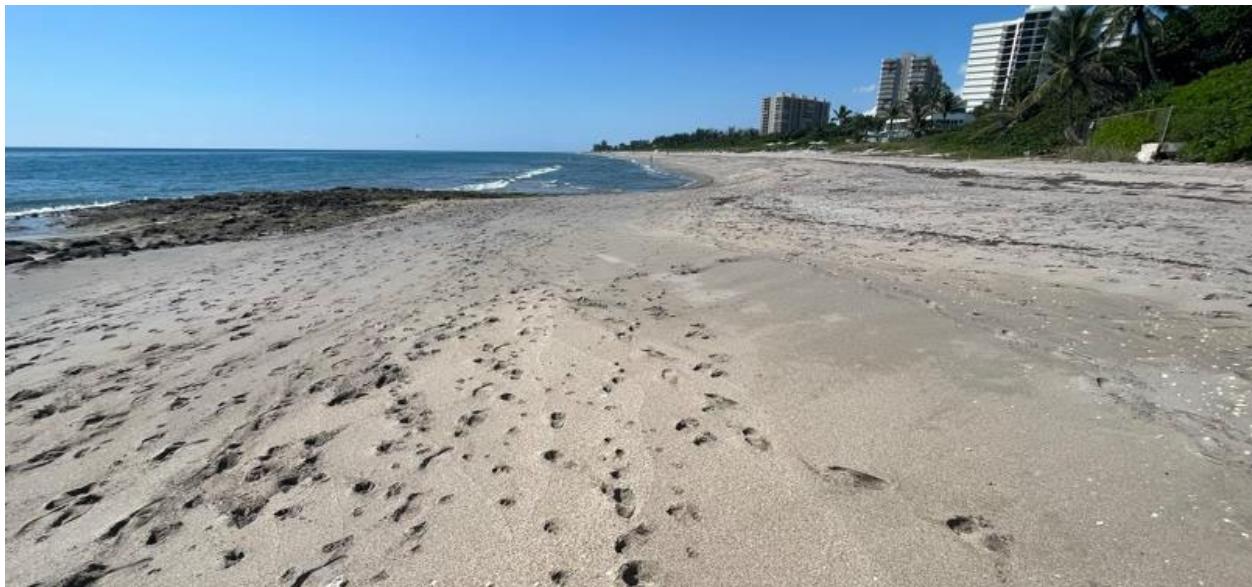
South of Yamato Rock, the beach is stable and healthy, and the three properties (4713, 4715 and 4801 South Ocean Boulevard) have a 50-foot-wide vegetated dune and an approximate 80 to 100-foot beach in front of the structures (Photo 13). Historically, this section of beach has benefited from the North Boca Raton Beach nourishment projects constructed in 1988, 1998, 2010, 2014, and 2020.

Photo 13. View of the beach looking south at Yamato Rock.

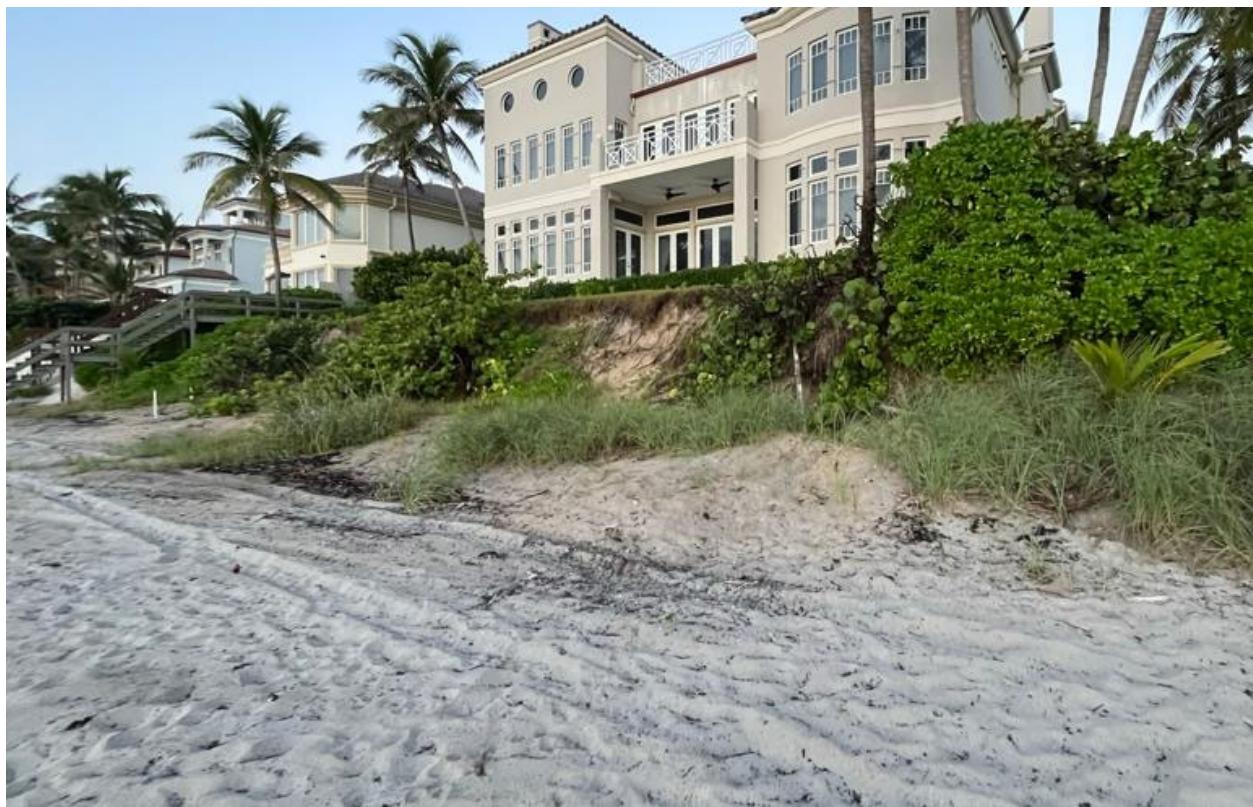
Beach Naupka is an exotic invasive plant that grows well on the dune face in Palm Beach County (Photo C-1). It is characterized by oval (or club shaped) shiny green leaves. It should be removed from all dune ecosystems as it crowds out and shades native dune species. Any FDEP permit issued will require its removal.

Photo C-1. Seagrapes at the left center of the photograph and Beach Naupka on the right side of the photograph.
